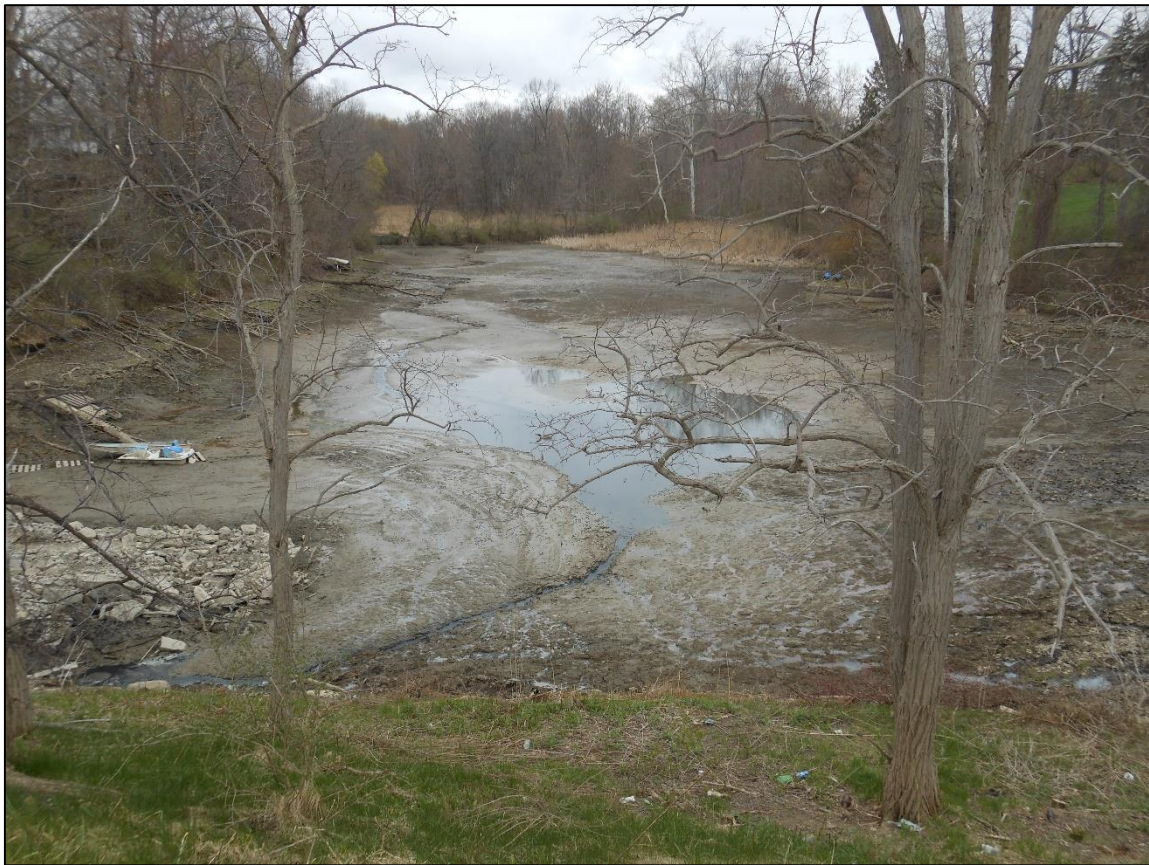
Dewatered pond facing upstream with stream channel beginning to establish (April 2015).

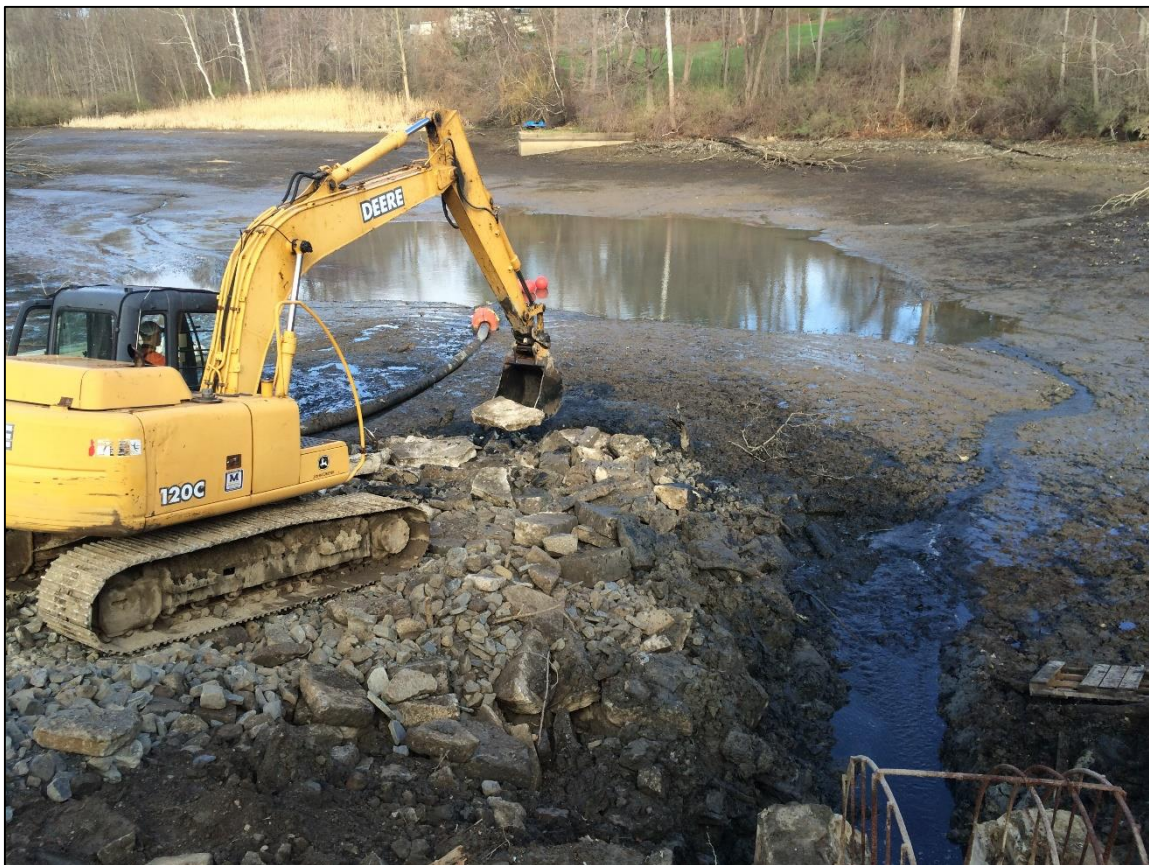
Construction of access road in dewatered pond to prepare for culvert boring with old spillway in foreground (April 2015).

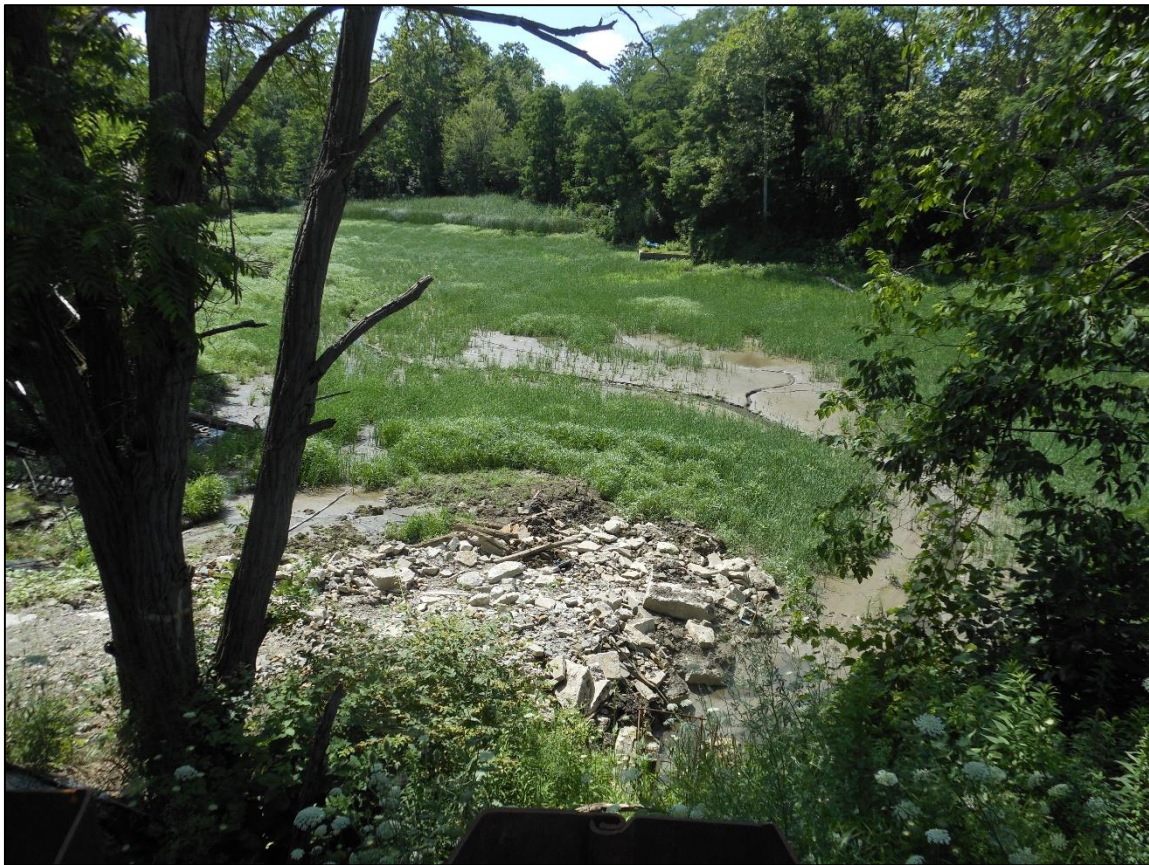
Natural vegetation establishment in dewatered pond (July 2015).

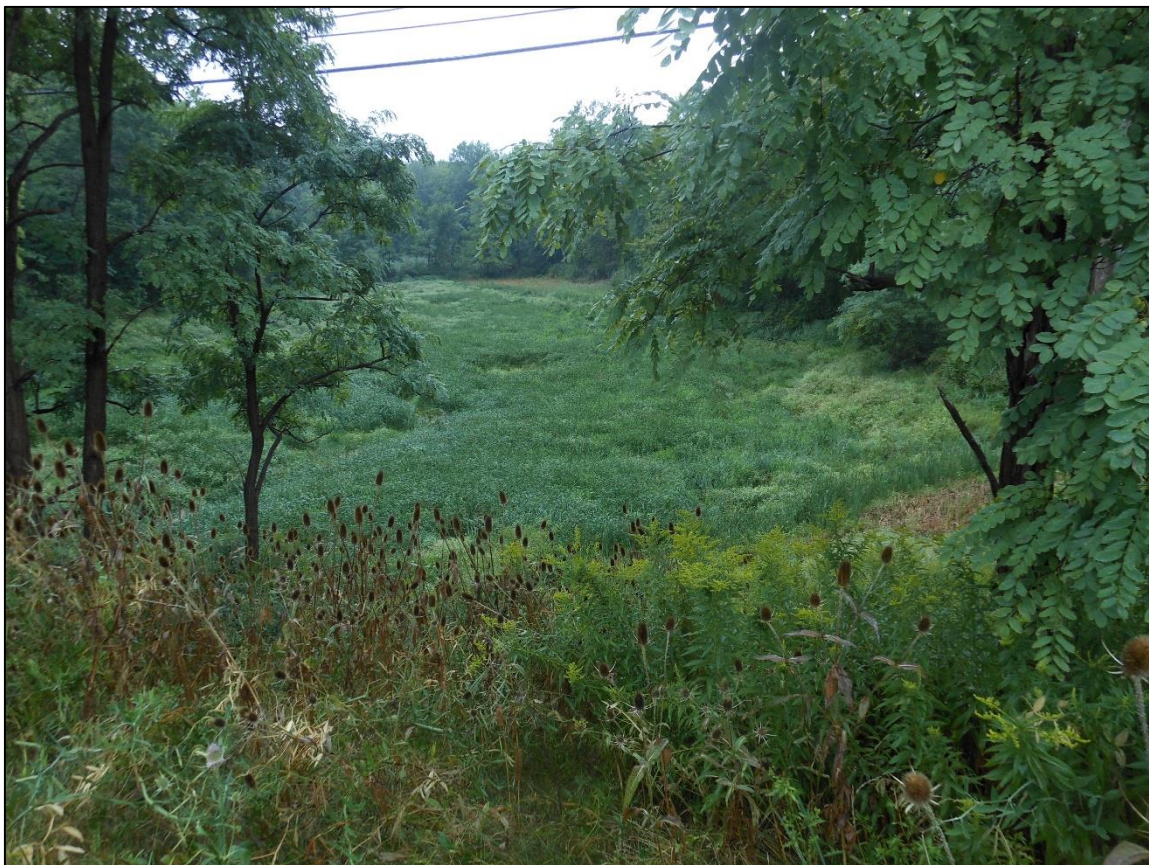
Vegetation establishment after native seed and cover crop seed applied (August 2015).

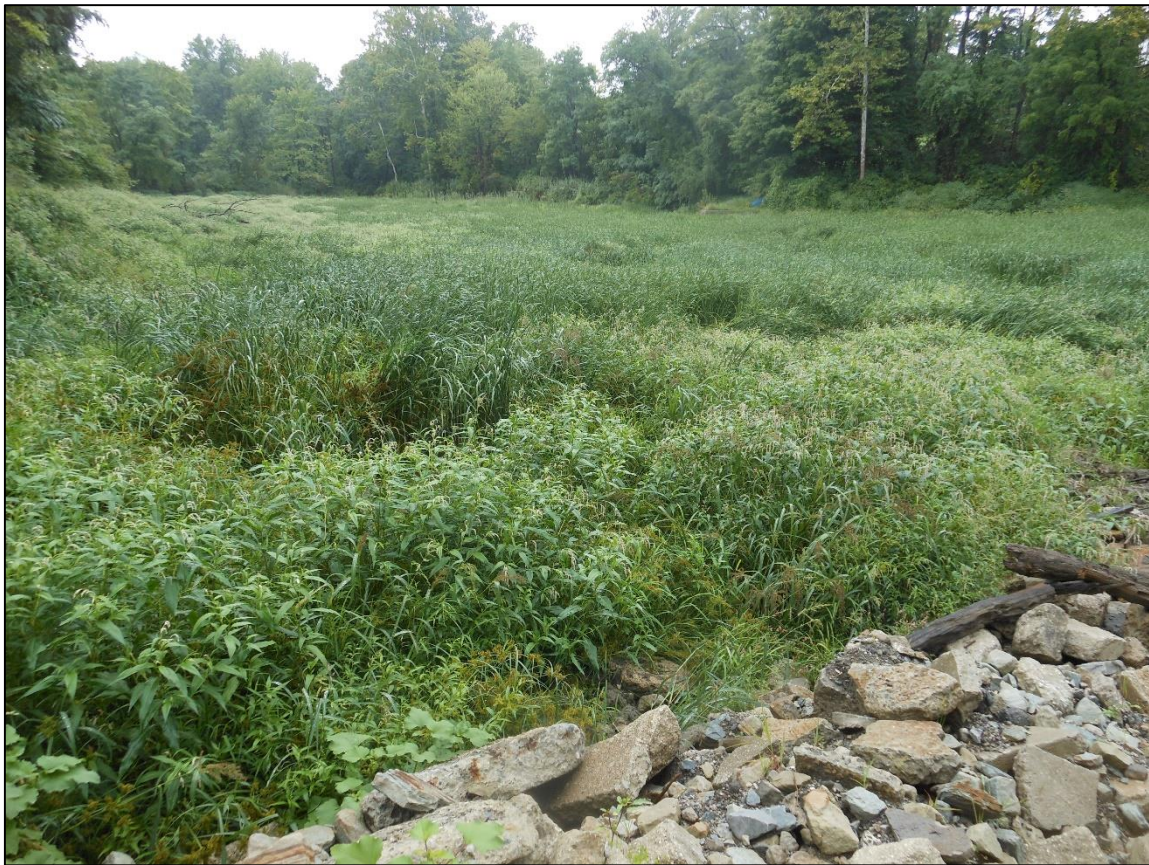
Vegetation establishment after native seed and cover crop seed applied (August 2015).

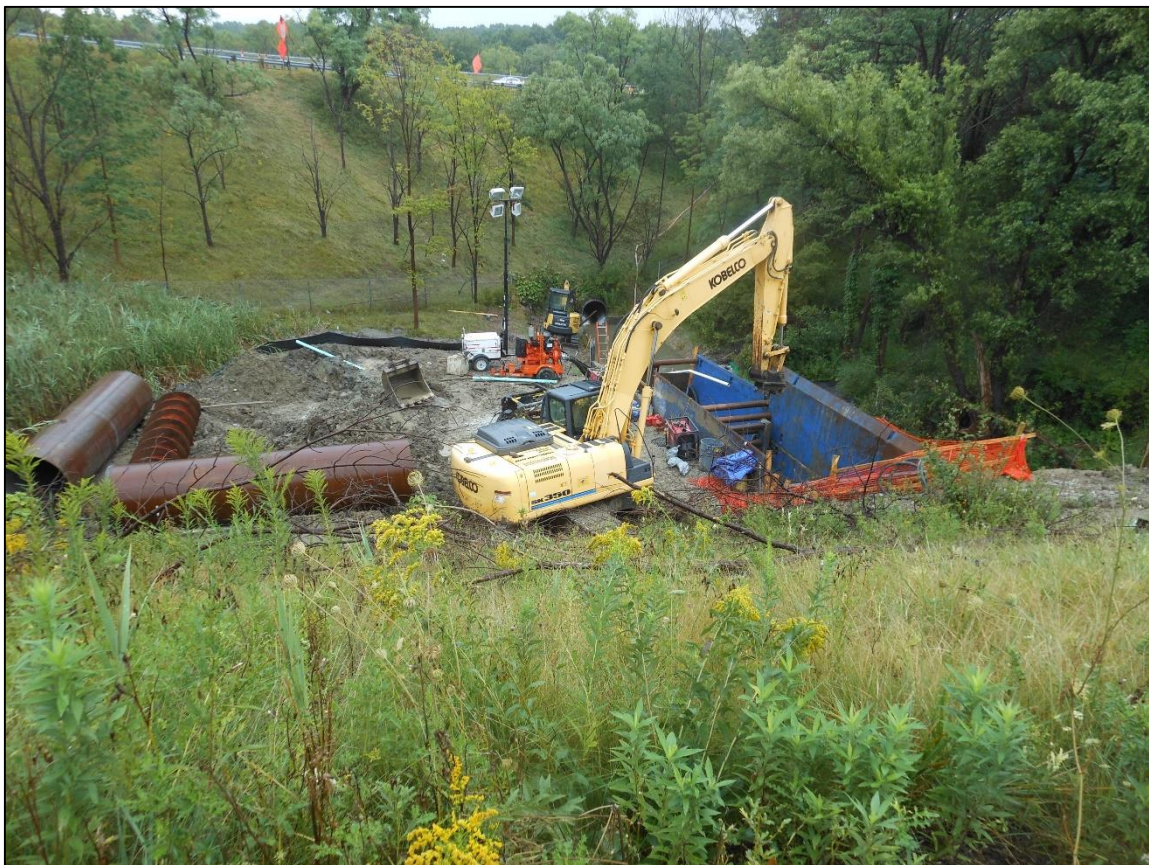
Boring pit for new culvert downstream of dewatered pond (August 2015).

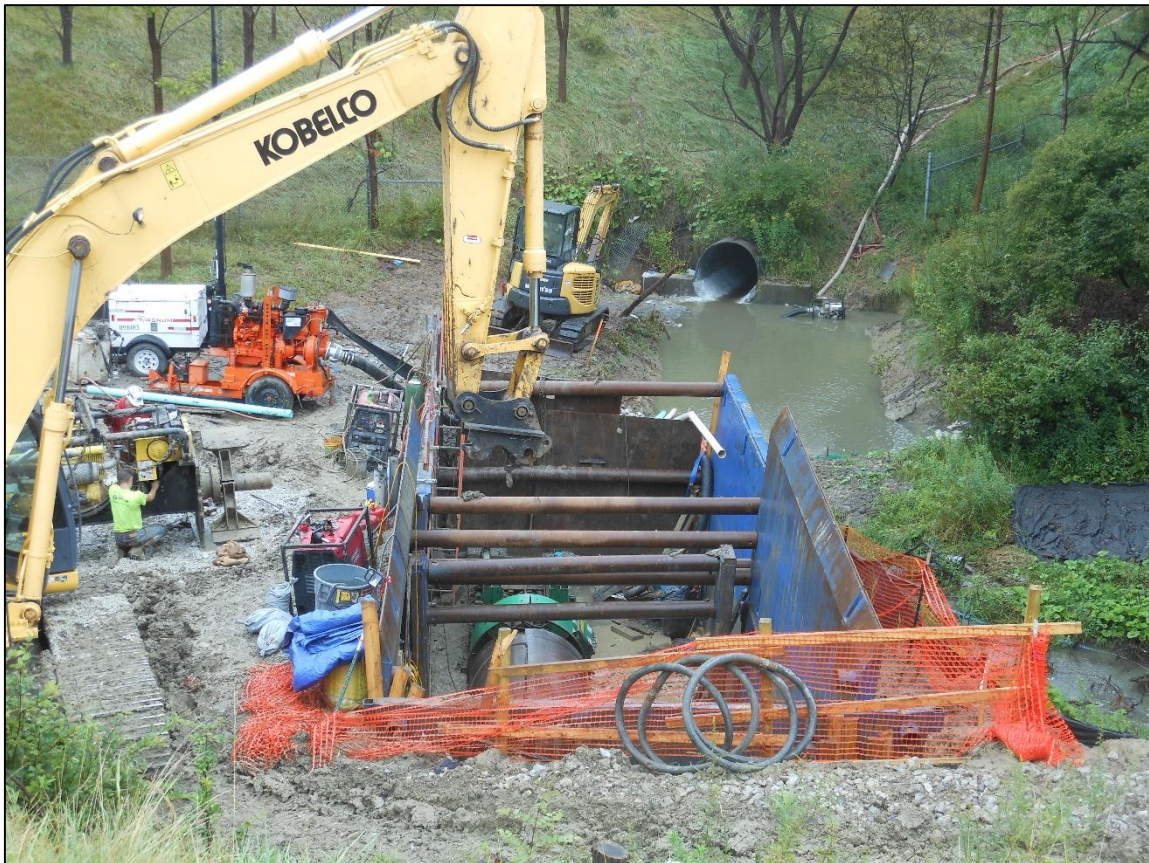
Close-up of culvert boring downstream of dewatered pond (August 2015).

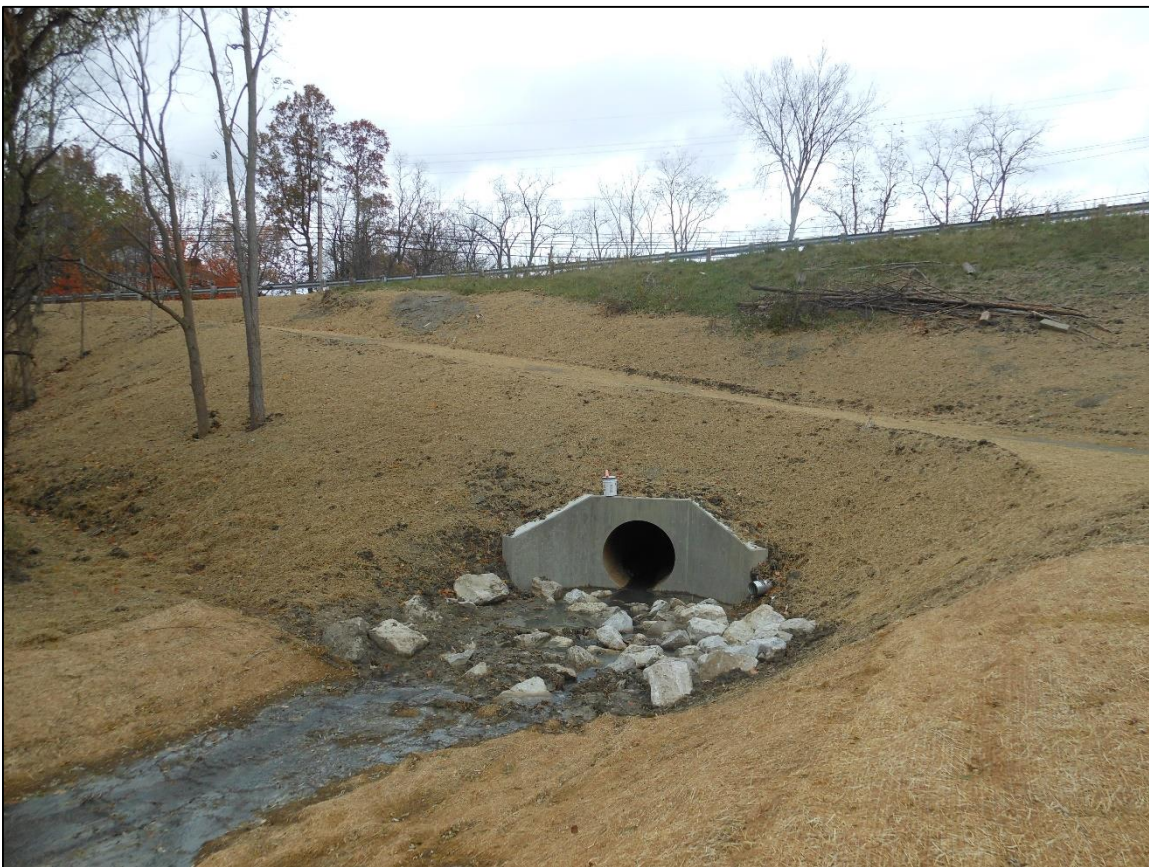
New culvert and headwall downstream of dewatered pond, facing southwest toward Morley Road (October 2015).

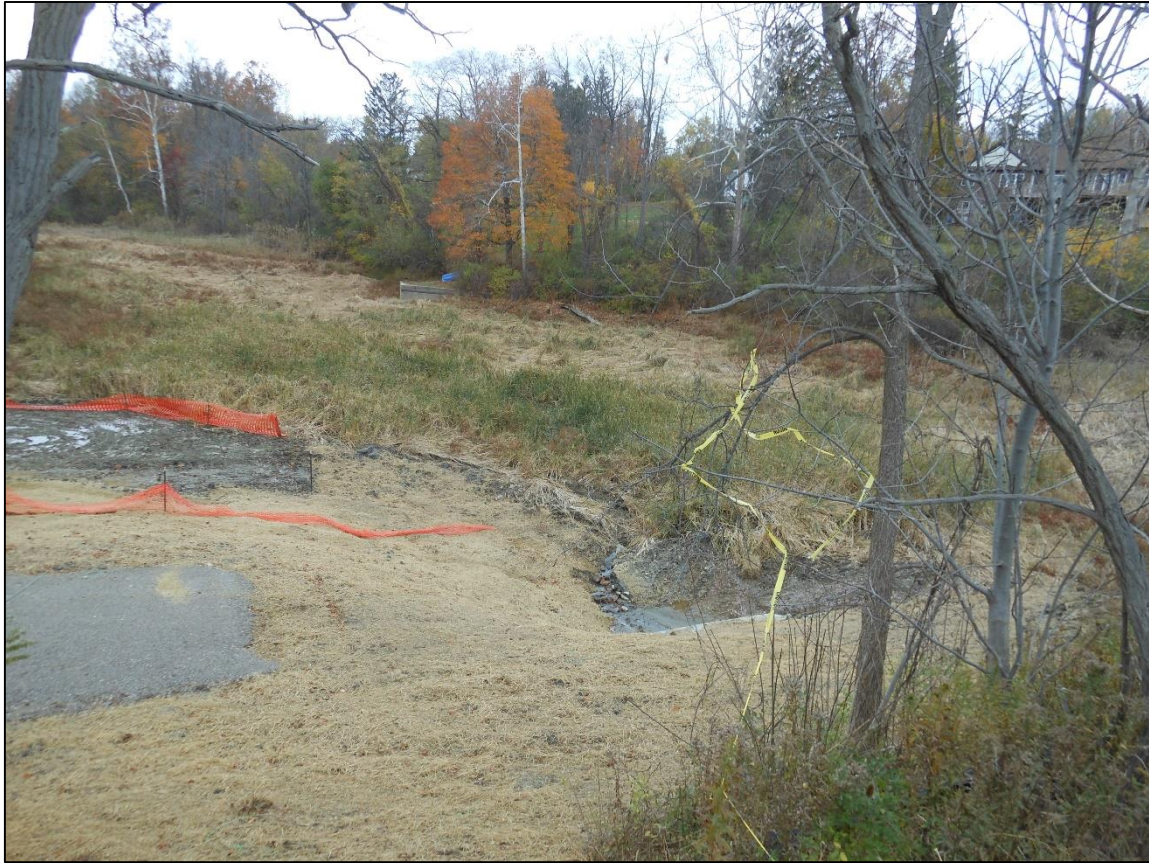
Dewatered pond with naturally established stream entering new culvert (October 2015).

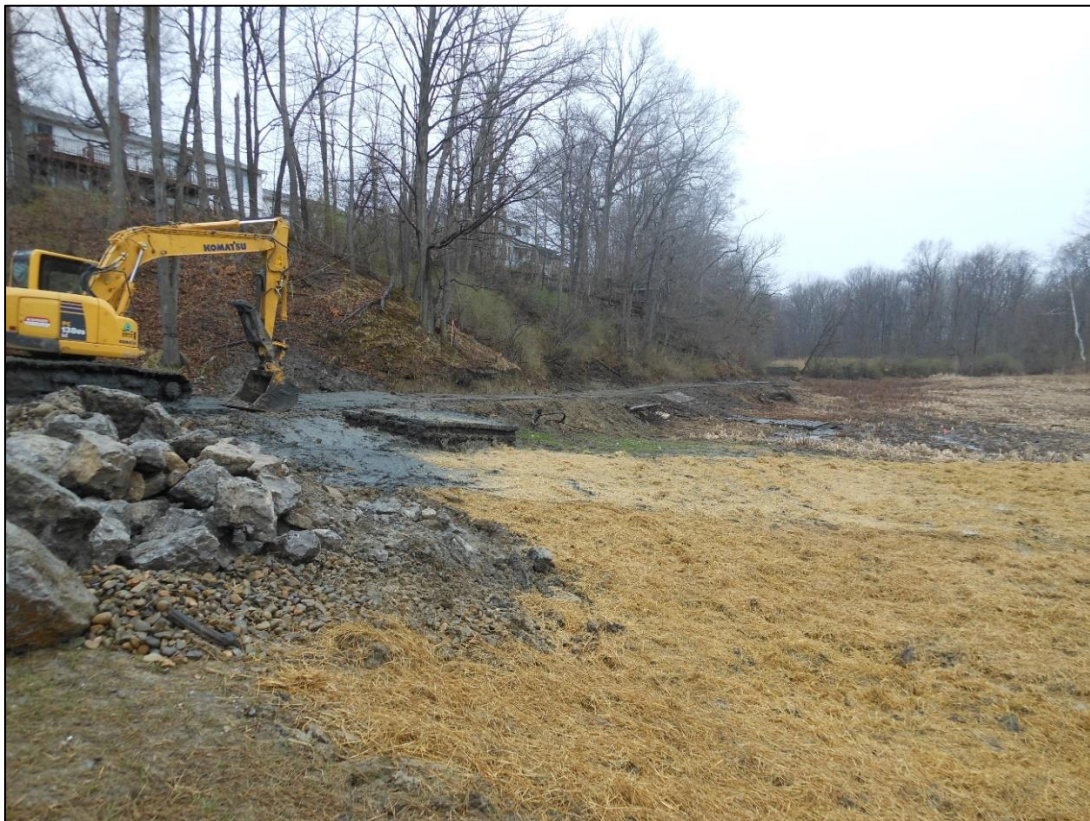
Construction crew working on temporary access road to reach upstream-most section of the restoration area (March 2016).

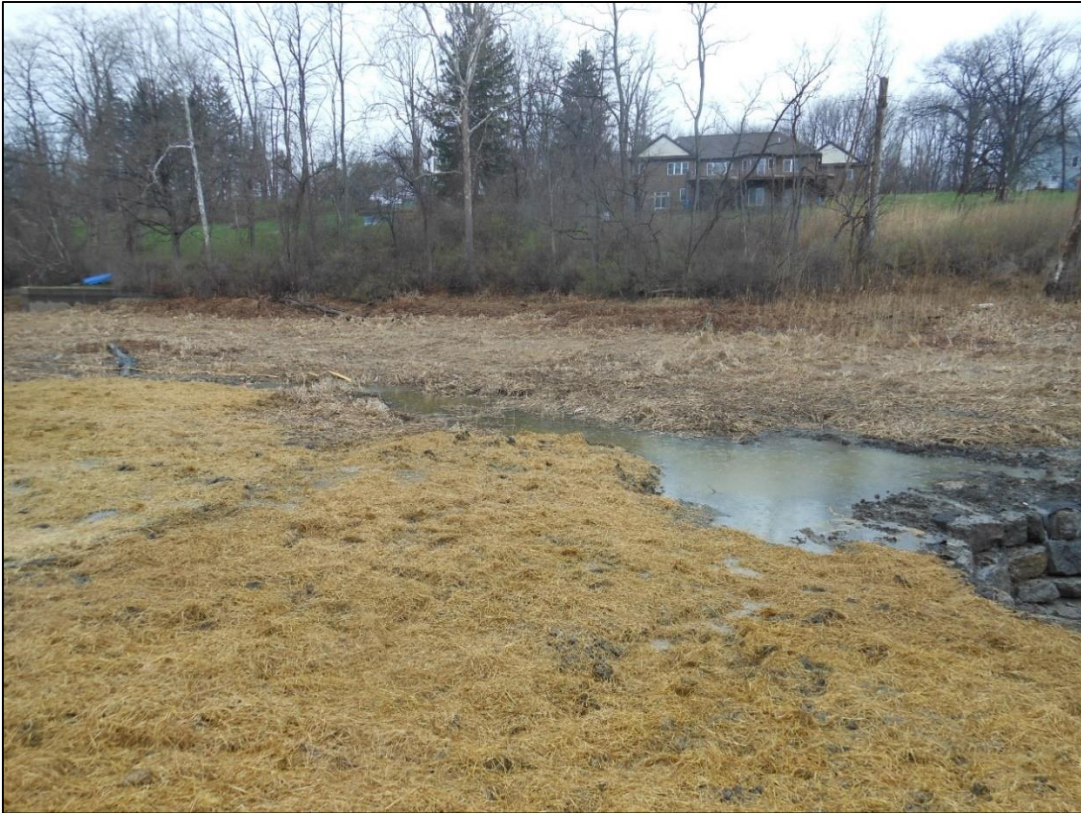
Newly installed log sill on the north bank of the stream to the left and the start of the cascade inlet structure to the new culvert on the right (March 2016).

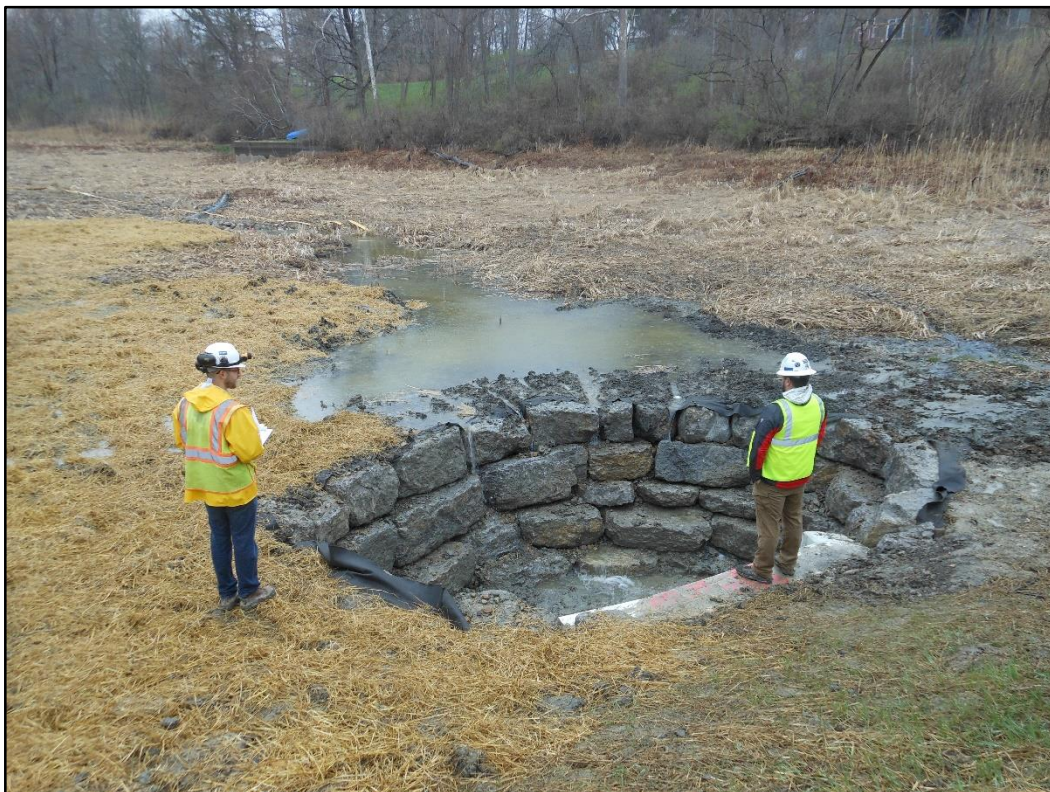
Newly installed cascade inlet structure to the new culvert on the right (March 2016).

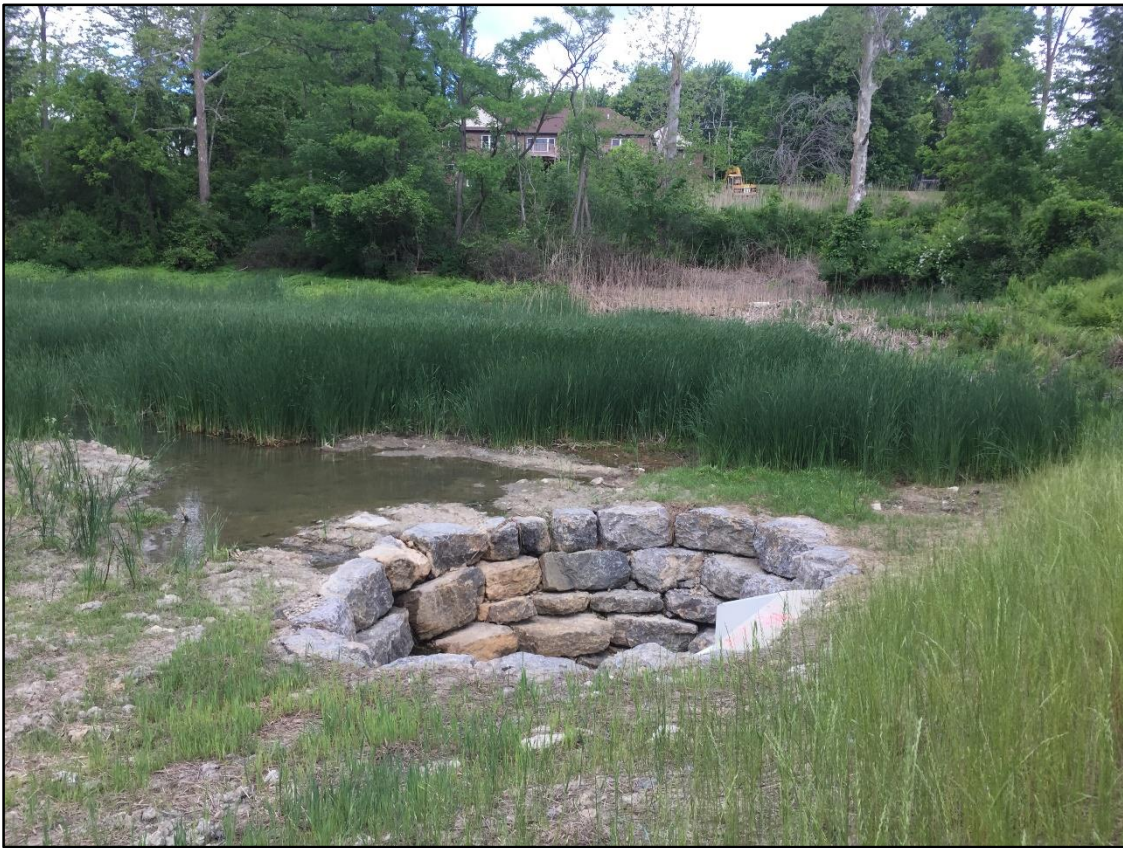
Cascade inlet structure to the new culvert on the right (June 2016).

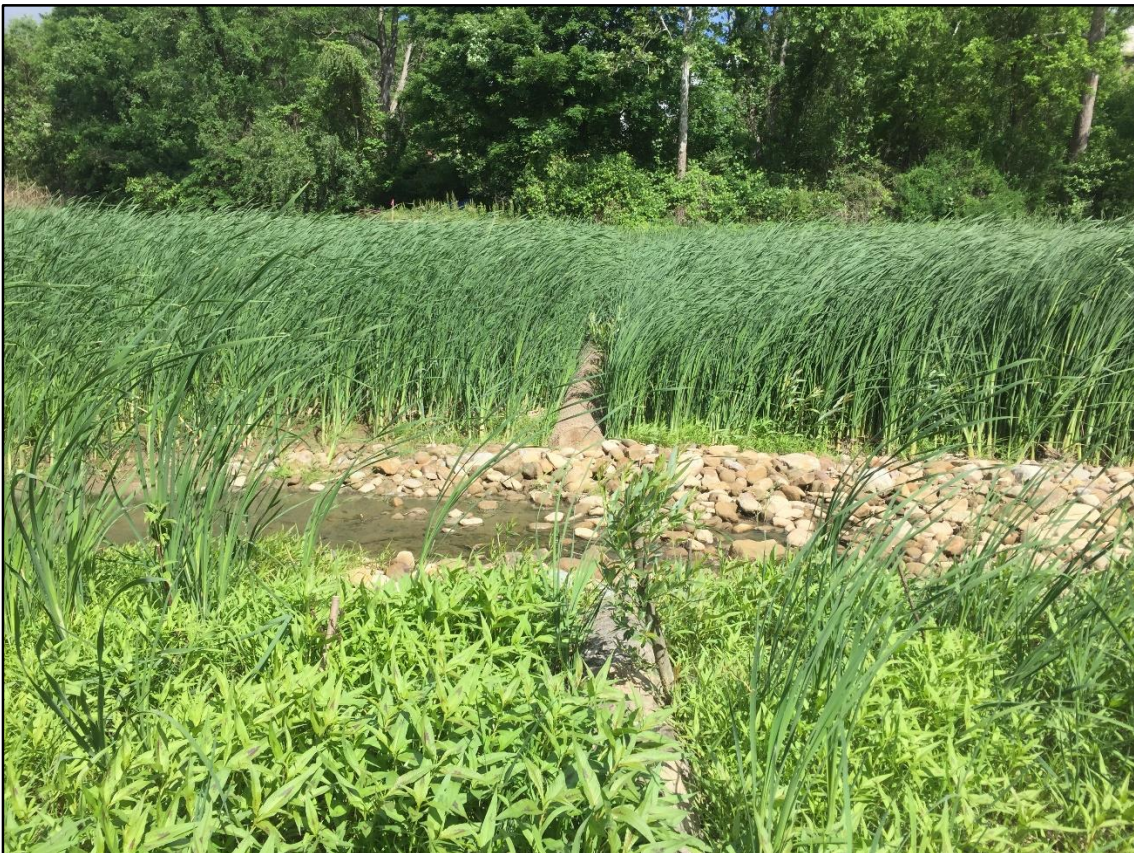
Log sill on the north and south bank of stream in center and start of riffle on the right (June 2016).

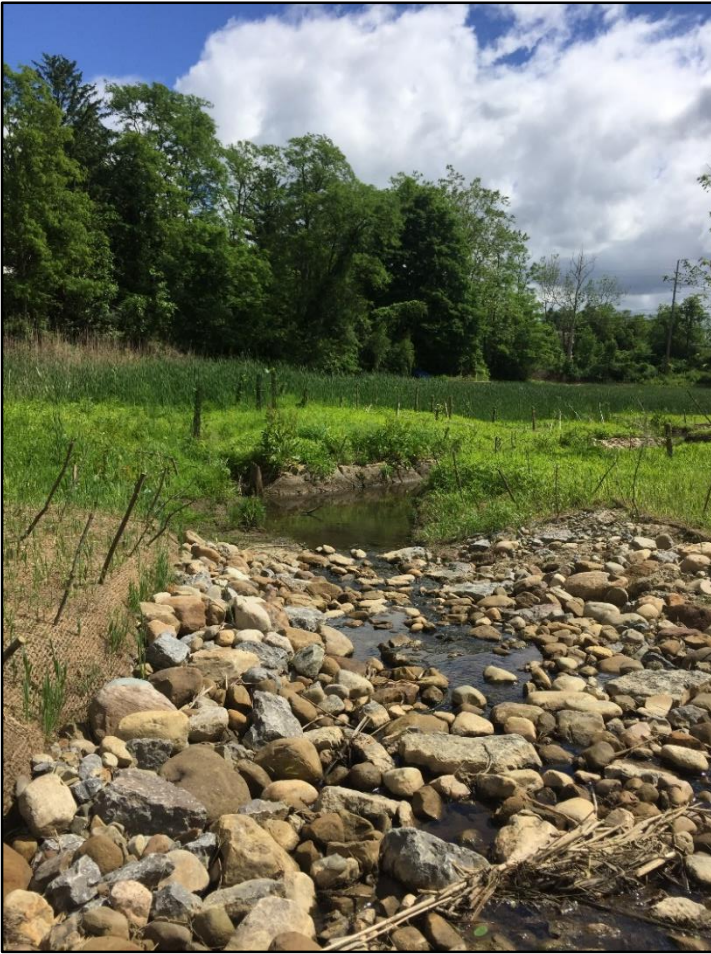
Upstream view of postings and riffle (June 2016).

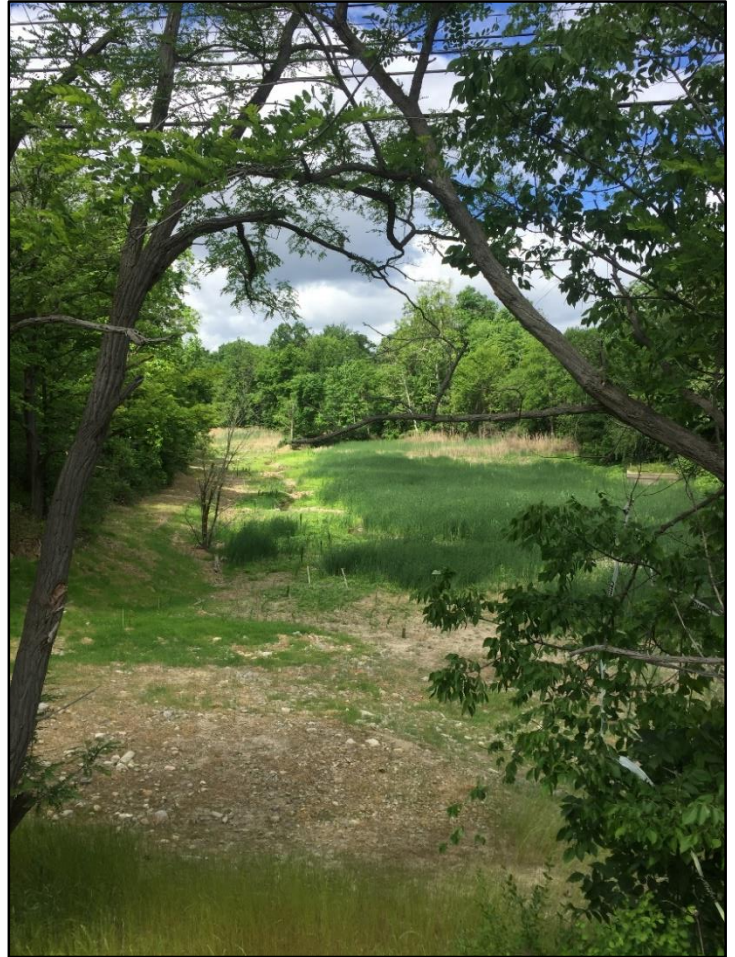
Upstream view of project area from Morley Road (June 2016),
